**Assessment and Analysis of Adaptation Alternatives  
For Coskata-Coatue Wildlife Refuge Properties**

**April 2022**

Woods Hole Group  
A CLS Company  
107 Waterhouse Road  
Bourne, MA 02532 USA  
(508) 540-8080

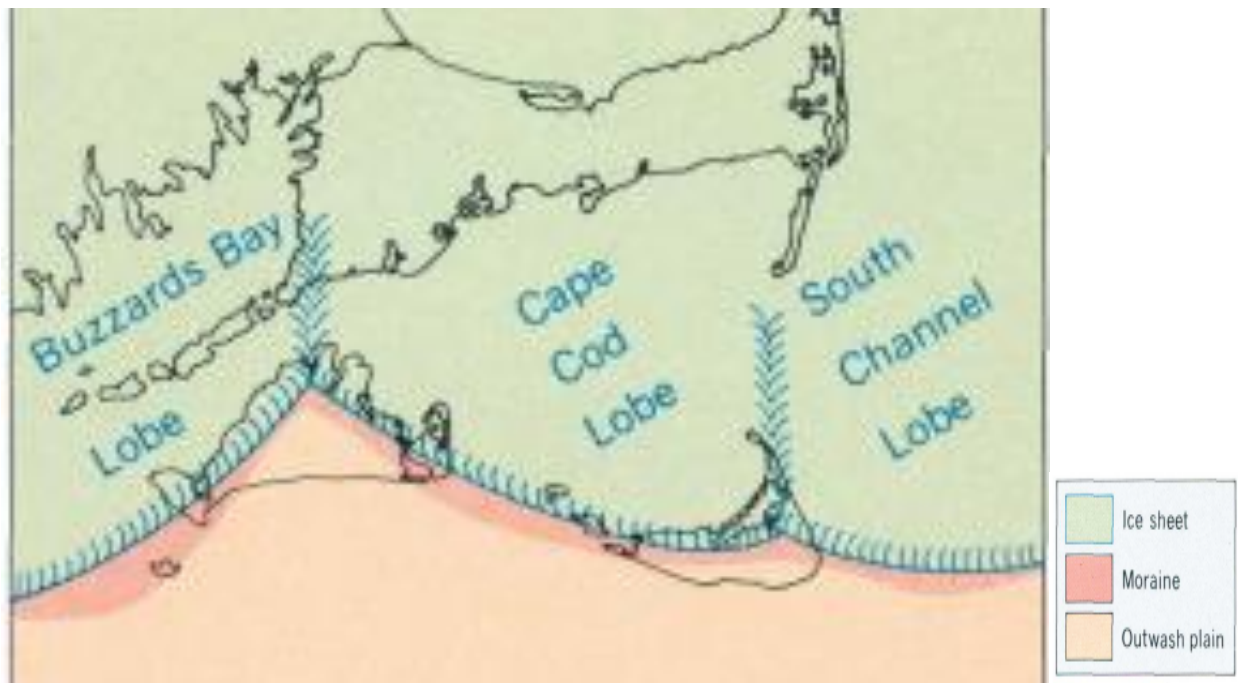
**Figure 2. Extents of Laurentide ice sheets (Oldale, Geologic History of Cape Cod, Massachusetts, 1976).**

Three major lobes of the Laurentide ice sheet covered the Cape and Islands region: Buzzards Bay Lobe, Cape Cod Bay Lobe, and the South Channel Lobe. During its advance, the glacier carved the land underneath, each lobe tearing off large pieces of bedrock from the terrain in its path, sculpting ridges and valleys, and grinding larger rocks into sand and silt-sized particles. Nantucket was formed at the interlobate intersection between the Cape Cod and South Channel lobes at the point of their farthest southerly advance around 21,000 years ago (Figure 2).

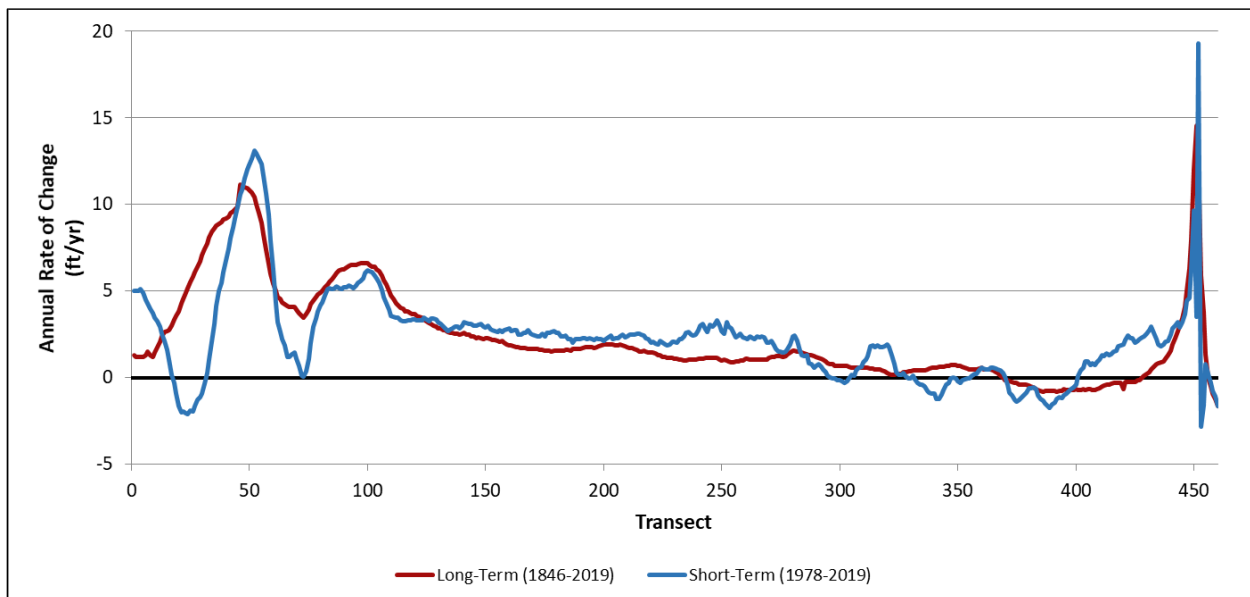
**Figure 10. Long-term (1846-2019) and Short-term (1978-2019) shoreline change rates for transects 1-460.**

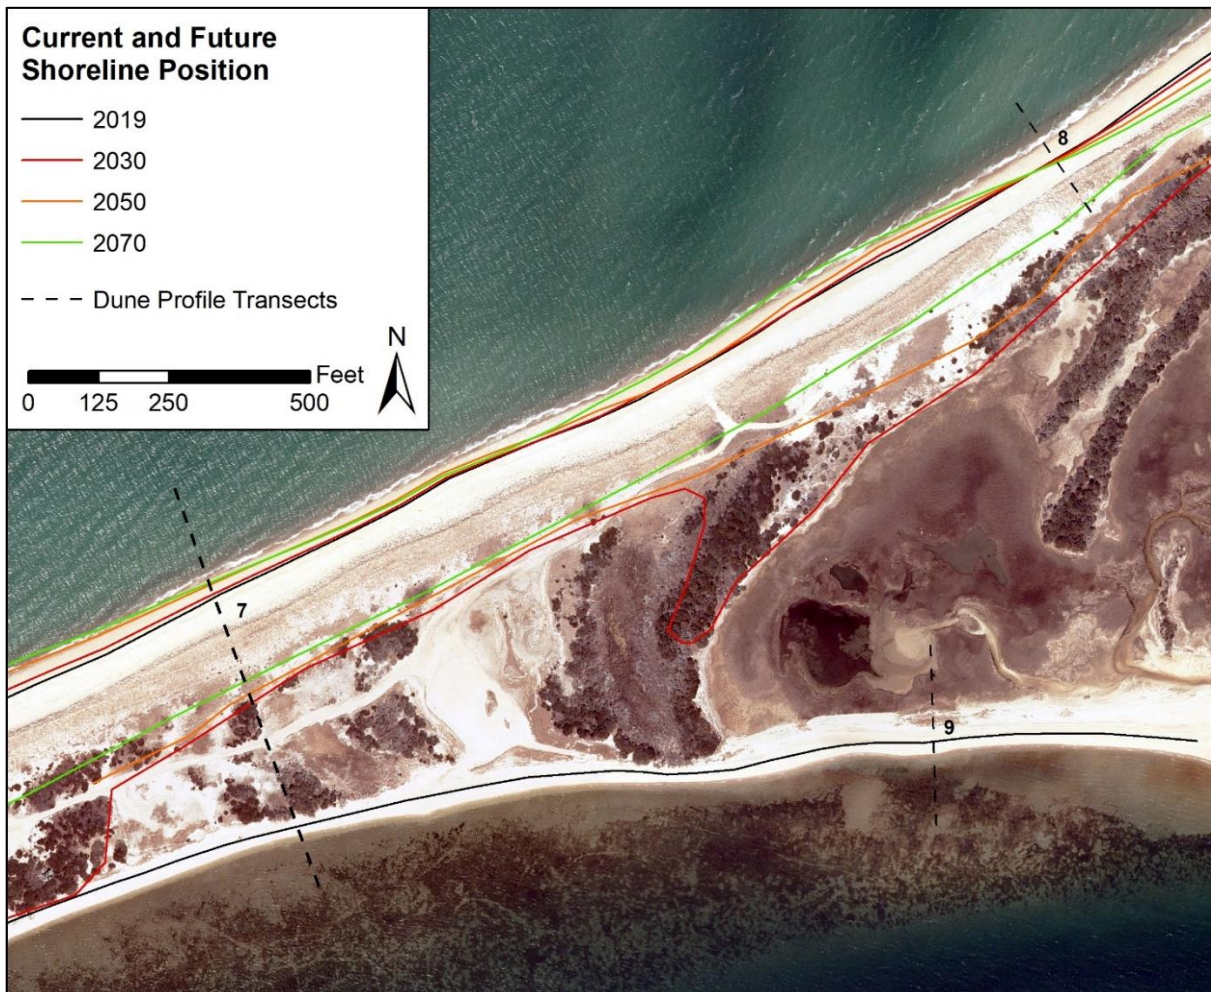
Figure 26. Current and future shoreline positions between 1st and 2nd Point. Dune profile transect data for Transect 7 is displayed in Figure 25.

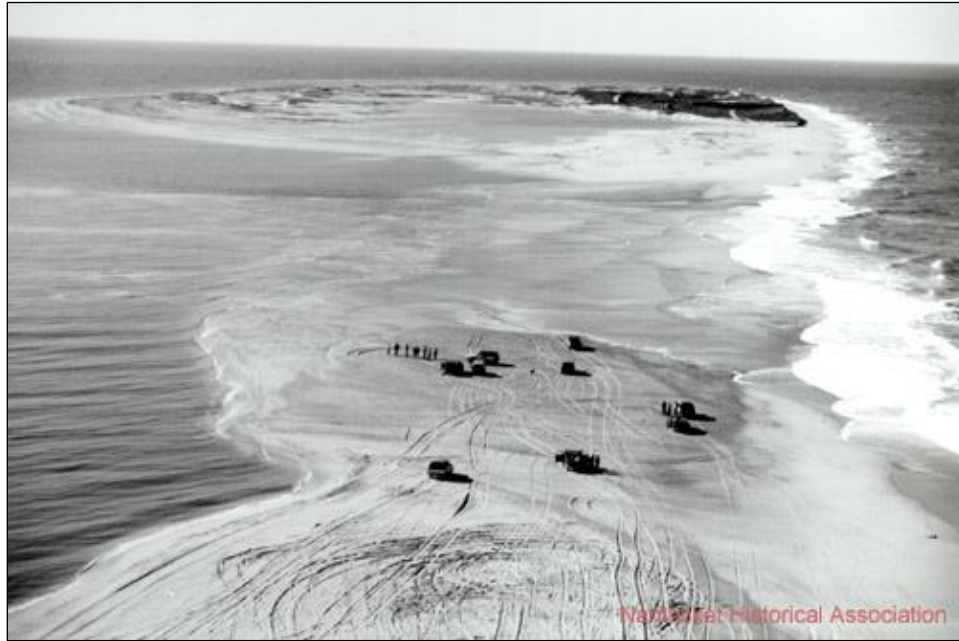
Figure 28. Overwash at The Galls in the 1970's (Image courtesy of Nantucket Historical Association).

These help to reinforce the legend and lore of the destructive effects of coastal storms on these exposed areas. Additional destructive events are known to have impacted this area, such as the March 1984 storm that felled the Great Point lighthouse and breached The Galls.

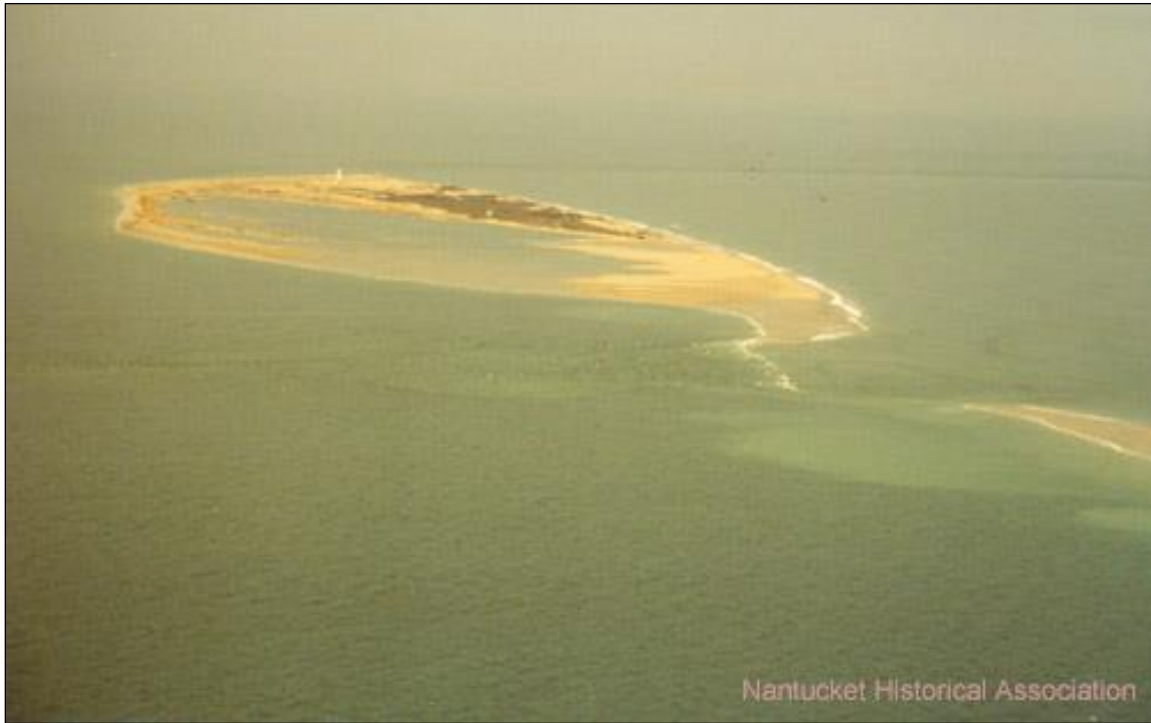
**Figure 29. Breach at The Galls after the December 1991 No Name storm (Image courtesy of Nantucket Historical Association).**

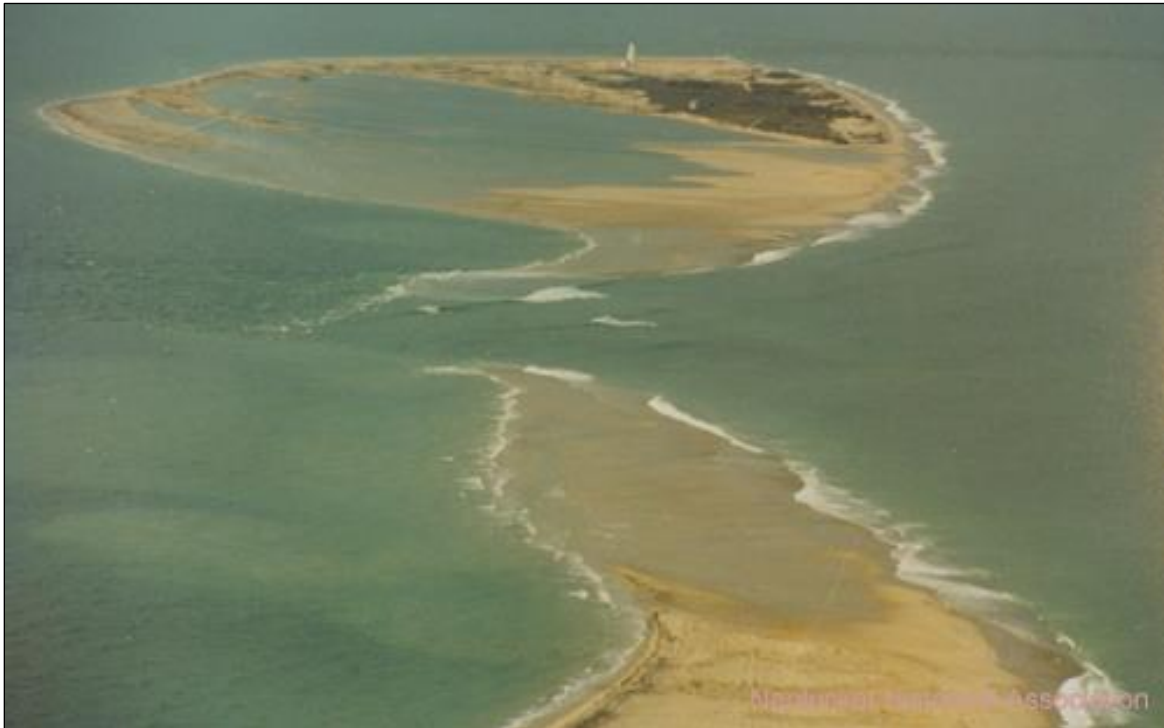
**Figure 30. Breach remaining at The Galls in January 1992 (Image courtesy of Nantucket Historical Association).**

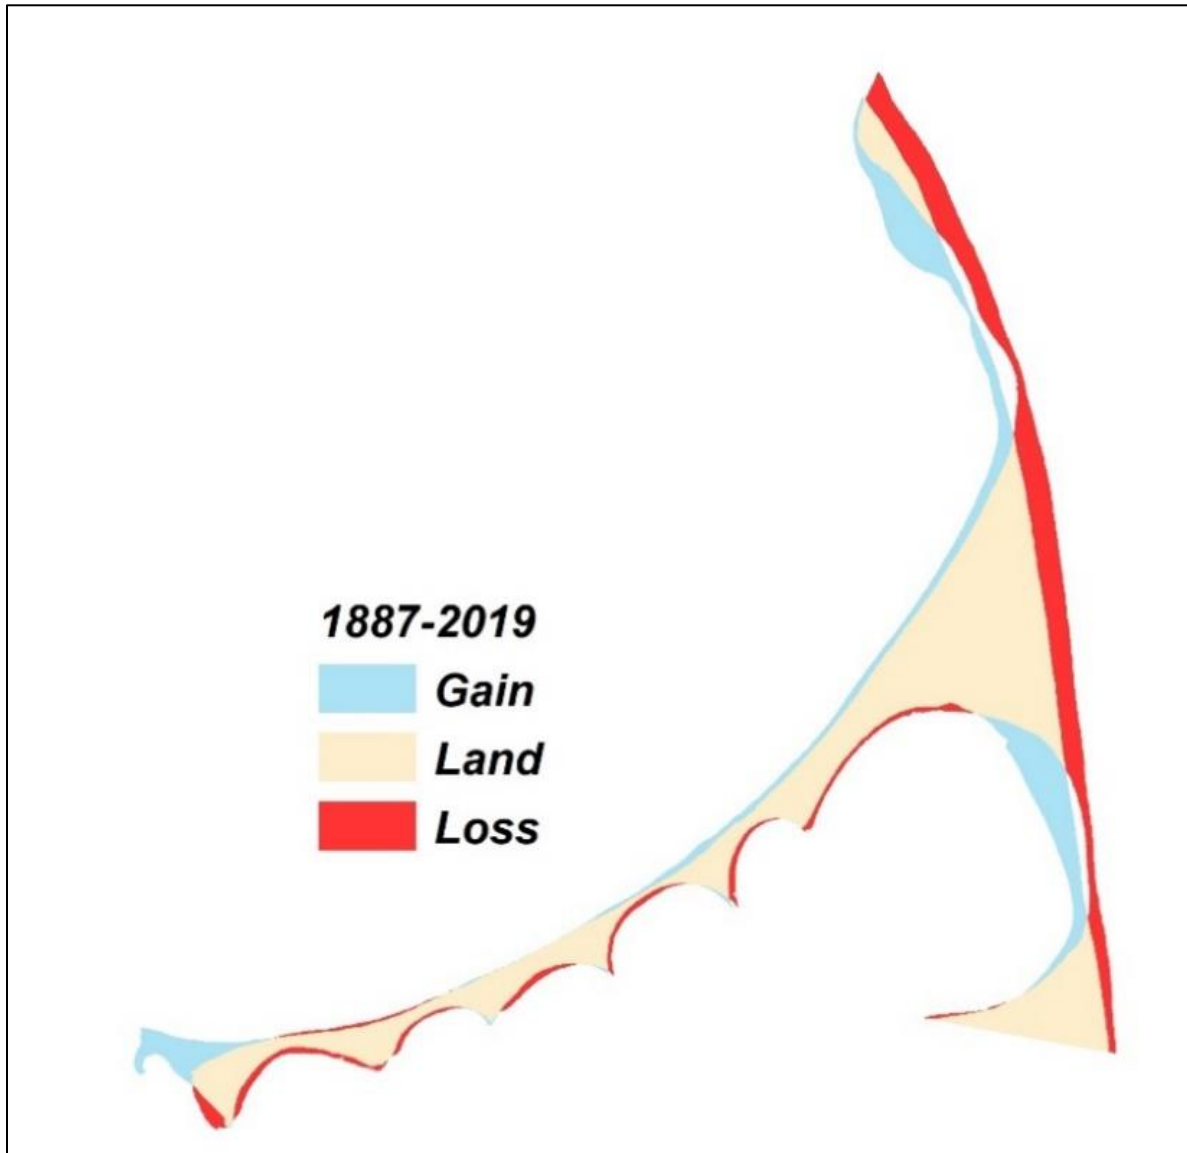
Figure 31. Overall shoreline change for Coskata-Coatue Study Area (1887-2019).

color, land that eroded is red, and land that was gained is blue. It is important to emphasize that land considered to have eroded (red) during any particular time frame is not necessarily lost from this barrier beach system. The land most likely shifted or transitioned to the position indicated in blue for that particular time frame. Figure 31 shows the overall change throughout the analysis timeframe (1887-2019) while Figure 32 shows the change between individual time periods.

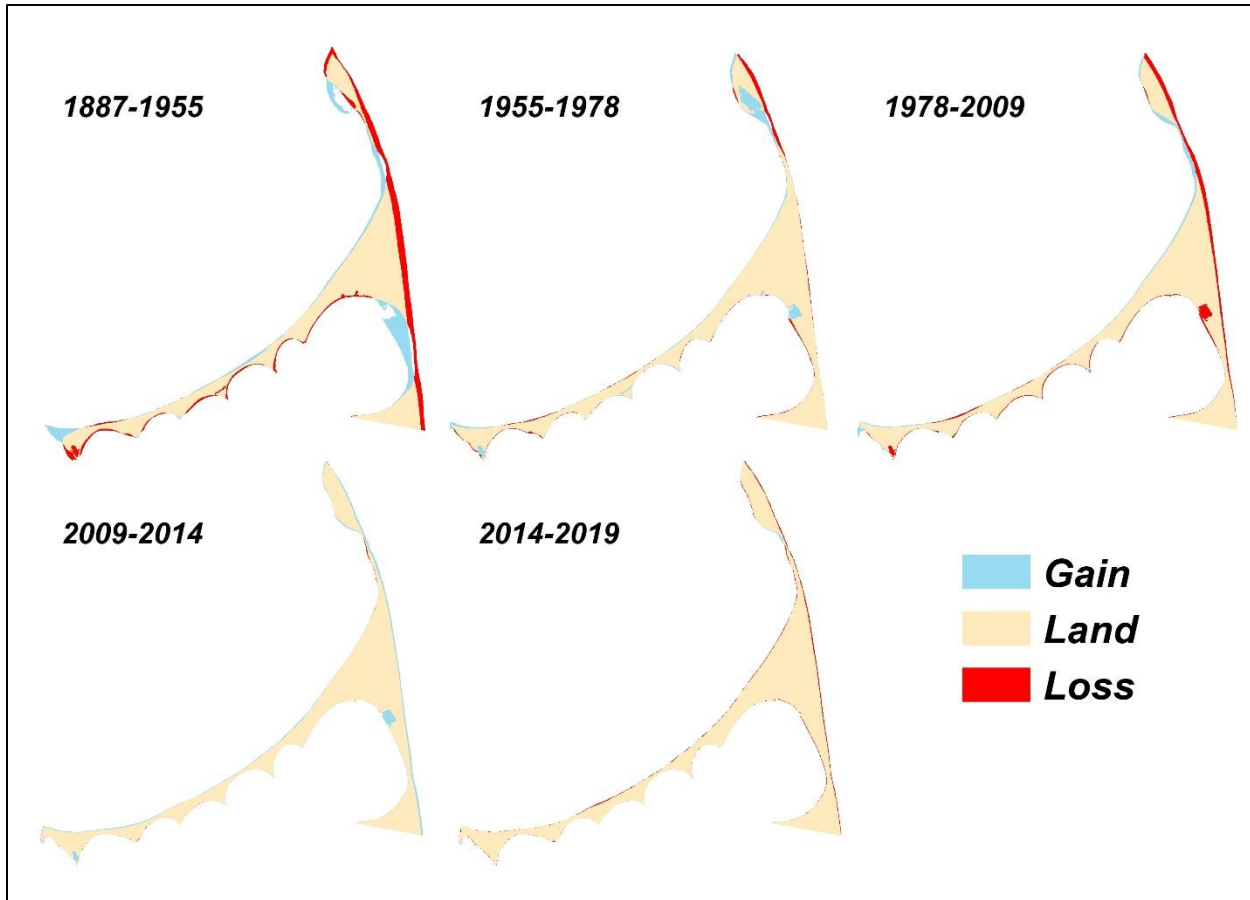
**Figure 32. Incremental shoreline change for Coskata-Coatue through time (1887-2018).**

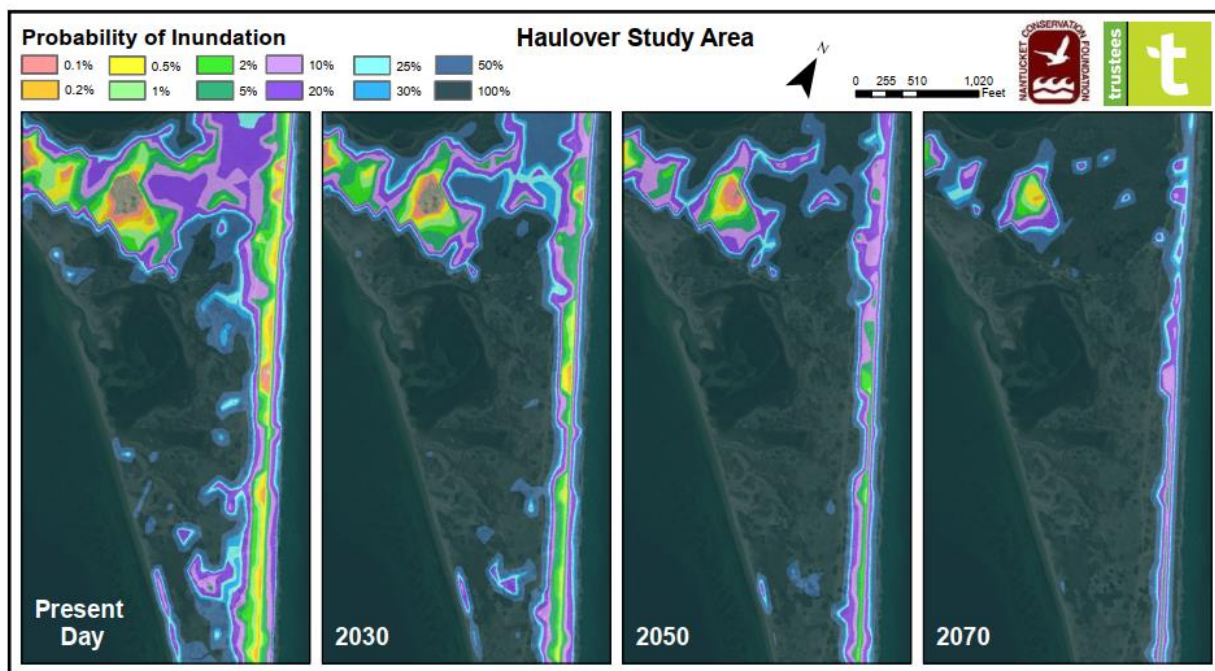
Figure 37. MC-FRM Probability of inundation results for The Haulover study area.

The Haulover study area is low-lying, fronted by the Atlantic Ocean, and backed by the Nantucket Harbor. Great Point Road runs along this study area providing access to Coskata-Coatue. The eastern shoreline facing the Atlantic Ocean is exposed to wave action increasing the risk of coastal erosion. Overall, this study area is primarily flooded from the Harbor and will become inundated under storm surge conditions annually starting in Present day (100% chance event). The crossover area between the Atlantic Ocean facing shoreline and the inner shoreline is also vulnerable to storm surge flooding. In Present Day, this area has an annual chance between 0.5% and 2% chance of flooding across the study area (Figure 37). This increases to 1-5% in 2030 and 2-10% in 2050, annually. By 2070, this area will have a 10-50% annual chance of experiencing flooding across the shoreline during coastal storms.

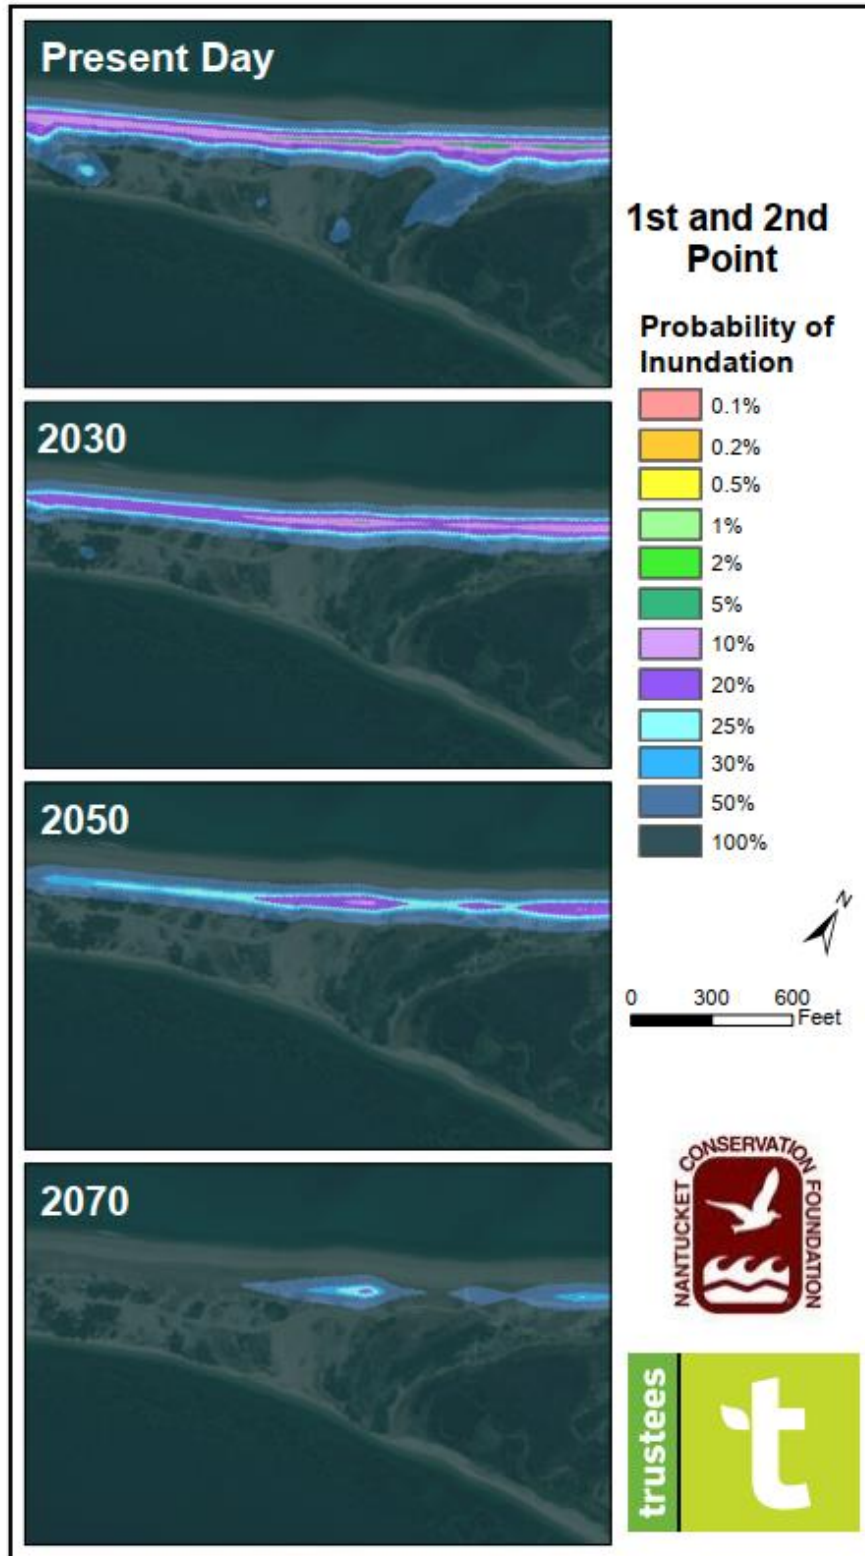
Figure 40. MC-FRM Probability of inundation results for the 1st and 2nd Point study area.

The area between 1st and 2nd Point is a stretch of low-lying beach that runs along Coatue Avenue. This area is exposed to wave action on the front side facing Nantucket sound and backed by Nantucket Harbor and is extremely vulnerable to storm surge. Overall, this study area is primarily flooded from the Harbor and will become inundated under storm surge conditions annually starting in Present day (100% chance event). This area is also vulnerable to total overwash activity (flooding crossing between Nantucket Sound and the Harbor). In Present Day, this area has at least a 10% annual chance of being flooded across the study area (Figure 40). This increases to 20% in 2030 and 25% in 2050, annually. By 2070, this area, annually, will experience flooding across the shoreline during coastal storms.

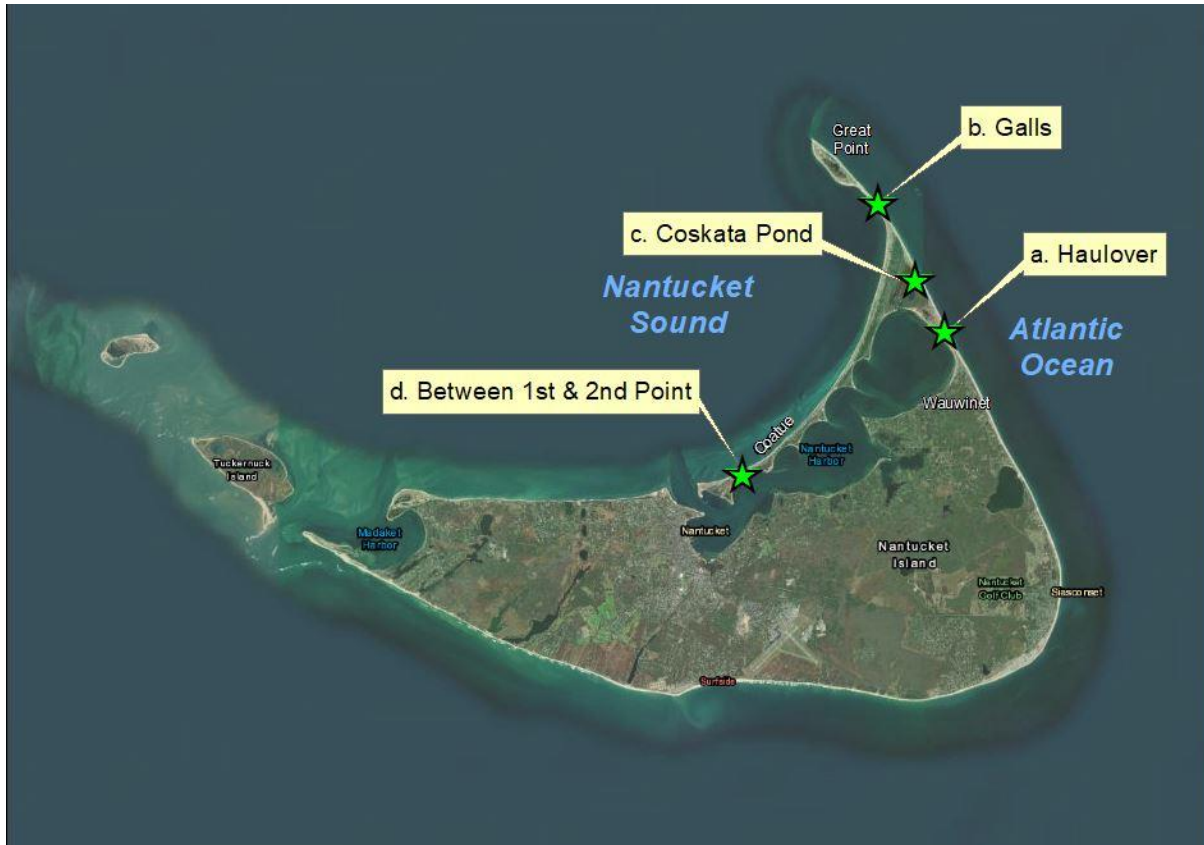
**Figure 42. Locus map of the four areas of interest.**

Tara Marden and Joel Kubick of the Woods Hole Group visited the Trustees’ and NCF’s properties on Coskata-Coatue on March 16, 2021, accompanied by Karen Beattie and Dr. Jennifer Karberg from the NCF and Shea Fee from the Trustees. The day long trip traversed the entire Coskata-Coatue Wildlife Refuge and included a more comprehensive stop and discussion at each of the sites shown in Figure 42. Observations from the day and evaluation of additional available information compiled specific to each of the four areas of interest are discussed below.

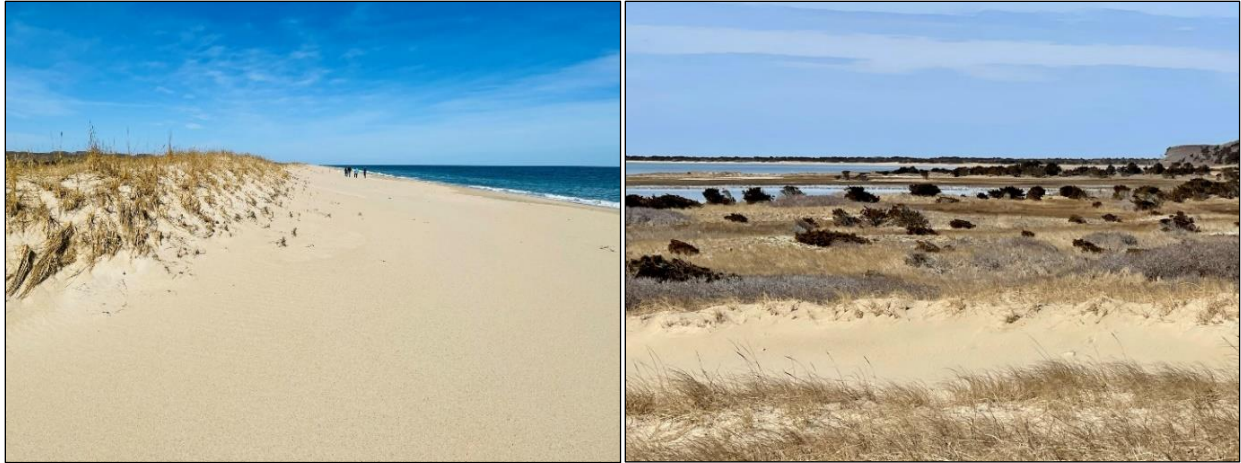
**Figure 43. The coastal beach and coastal dune at The Haulover; the ocean-facing coastal beach facing north (left); the views from the primary dune crest at The Haulover - looking west towards Nantucket Harbor (right).**

The Haulover is a narrow section of low-lying topography that separates the Atlantic Ocean to the east and Nantucket Harbor to the west. Despite its small area, it contains a variety of habitats, including coastal beaches and dunes, salt marsh and tidal flats, freshwater wetlands, and an upland maritime forest. The ocean-facing coastal each is relatively wide with a gentle slope and is comprised of medium to coarse grained sand (Figure 43 left). The coastal dune is vegetated predominantly with beach grass, but also contains eastern red cedars and other maritime shrubs (e.g., northern bayberry) (Figure 43 right). The seaward face of the coastal dune extends approximately five (5) feet high from the coastal beach. Portions of the foredune ridge showed evidence of recent erosion, but the overall coastal dune system is expansive and healthy despite its low profile.

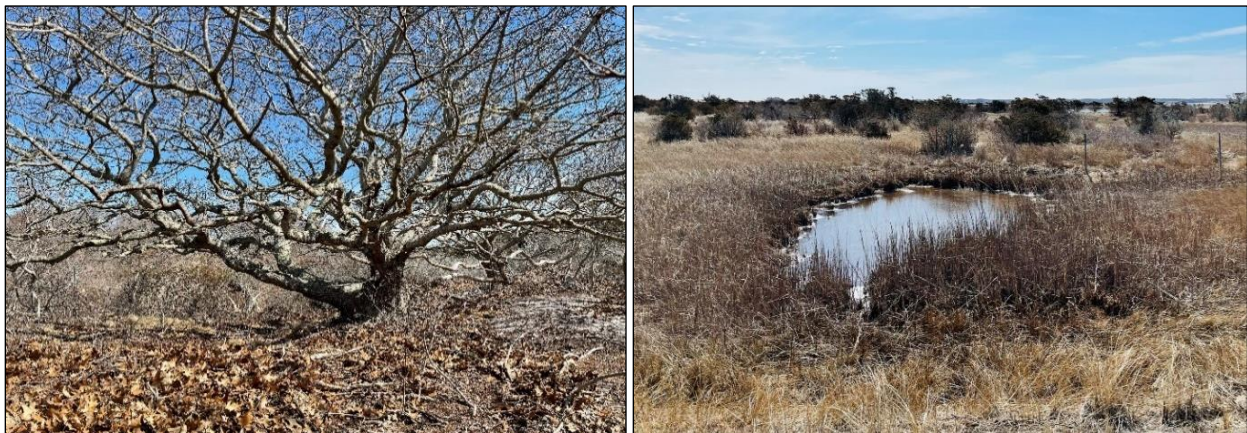
**Figure 44. Other habitats present at The Haulover include: a maritime forest (left) and a freshwater wetland (right).**

Along the northern extent of The Haulover, the site transitions from a barrier beach coastal dune system to a maritime forest, dominated by oaks (Figure 44 left) and eastern red cedar. There is a small freshwater wetland (Figure 44 right) just south of the maritime forest. In addition, a corrugated plastic pipe runs under the road that circles the southern boundary of the maritime forest (Figure 45). The flow from this pipe drains into a relatively large salt marsh (Figure 46) surrounding Haulover Pond on the Harbor side of the barrier beach. American oystercatchers regularly use the Nantucket Harbor shoreline in this area for nesting.

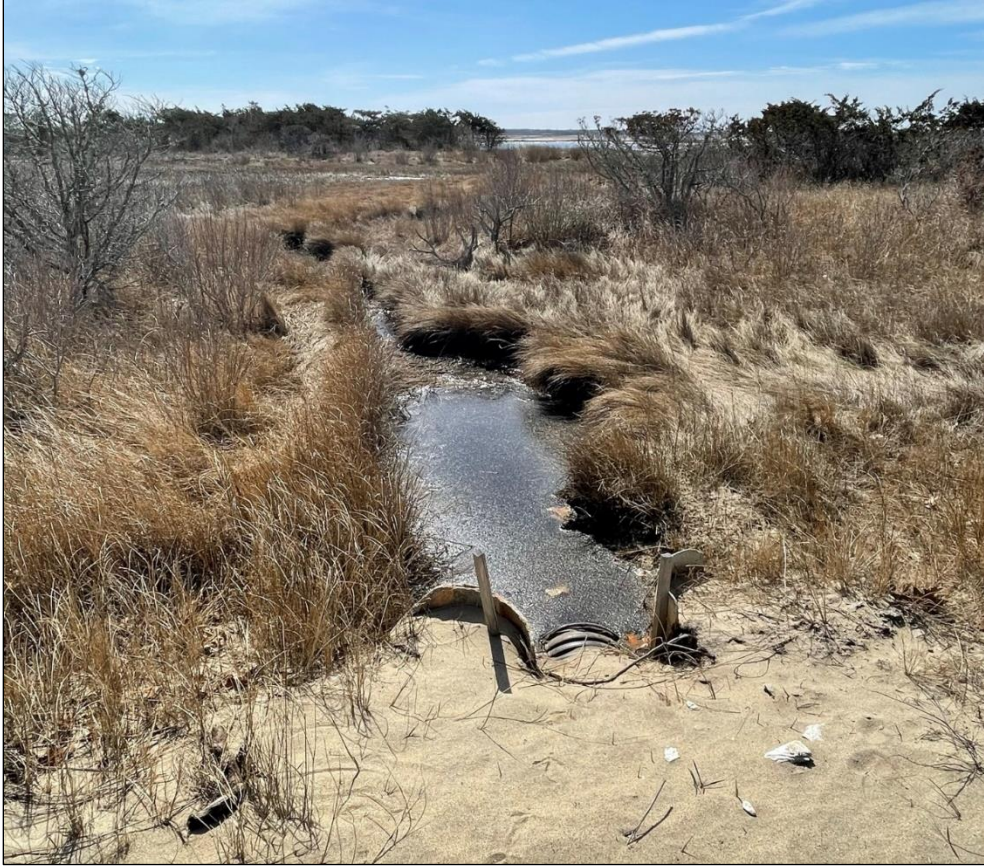
**Figure 45. Existing corrugated plastic pipe under road.**

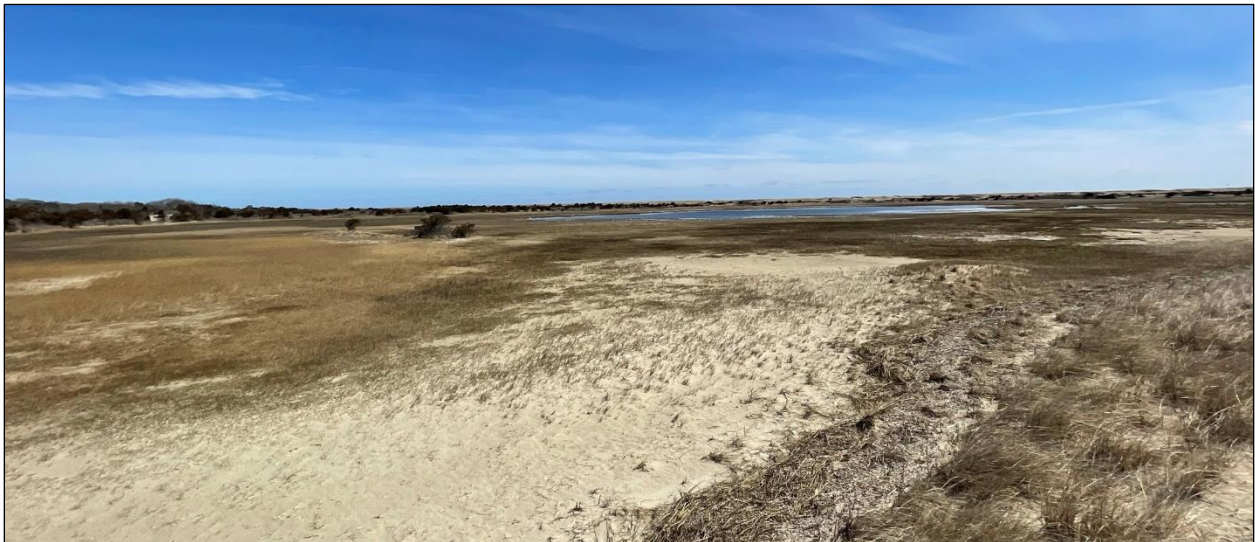
**Figure 46. Existing salt marsh on the Nantucket Harbor side of the barrier beach at The Haulover.**

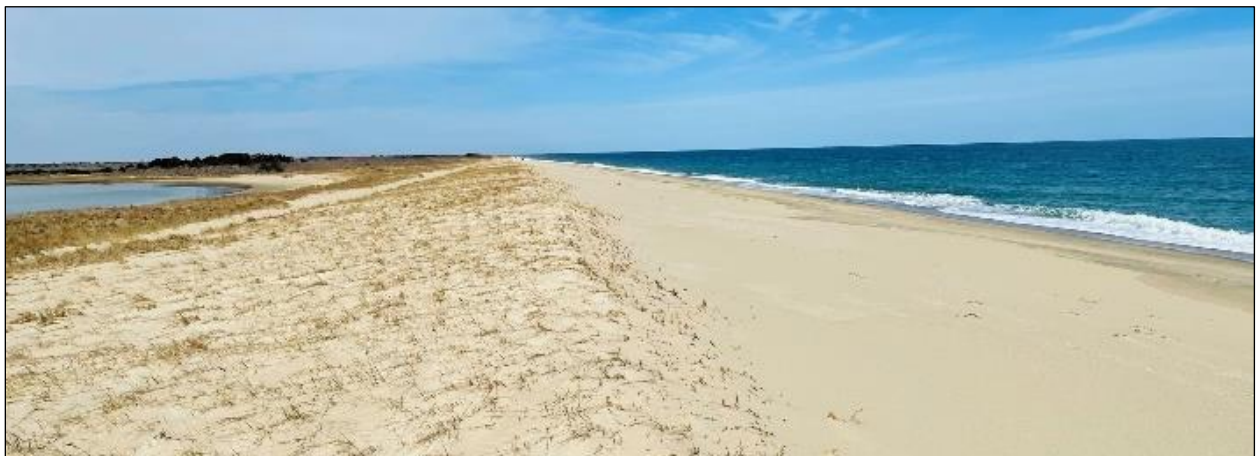
Figure 51. Barrier beach between the Atlantic Ocean and Coskata Pond - looking north.

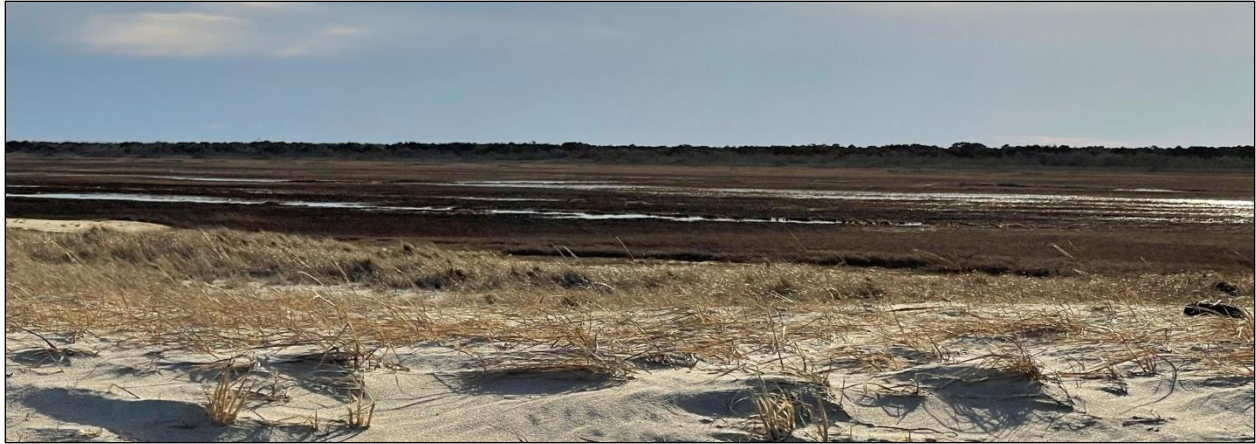
Figure 52. Extensive salt marsh northwest of Coskata Pond.

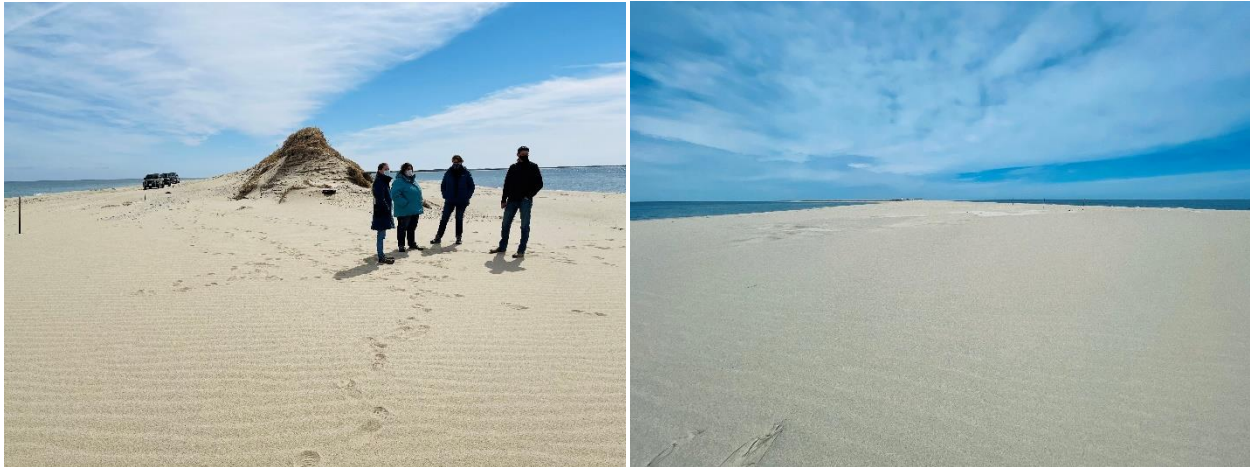
Figure 55. South and north-facing views from The Galls looking at the remaining dune crest (left) and a large overwash fan that developed during a storm (right).

The Galls is a section of narrow, low lying coastal beach (Figure 55). The Galls divides the Atlantic Ocean to the east and Nantucket Sound to the west and connects the area around the Great Point Lighthouse to the north with the elbow of Coskata-Coatue. The wide, gently sloping beach is often over washed during even moderate coastal storms and occasionally breaches during larger storms (e.g., 1984 and 1991). Figure 55 shows views looking southeast at the dune crest (right) and north at the large overwash fan that developed during a storm (left). Figure 56 provides the DEP wetland mapping of this area, which shows only a single wetland resource type across the entire subsite: coastal beach. Healthy and robust coastal dunes with an approximately crest elevation of 16 feet NAVD88 (based on the 2018 LiDAR) extend northwest and southeast from The Galls.

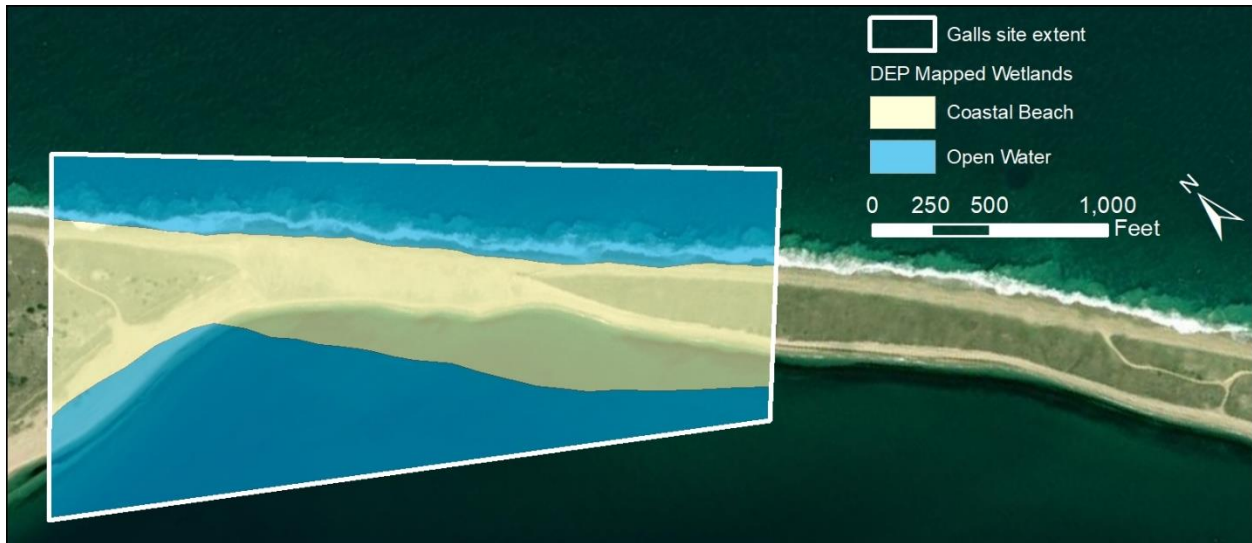
Figure 56. Existing wetland resource areas, as mapped by MassDEP, at The Galls.

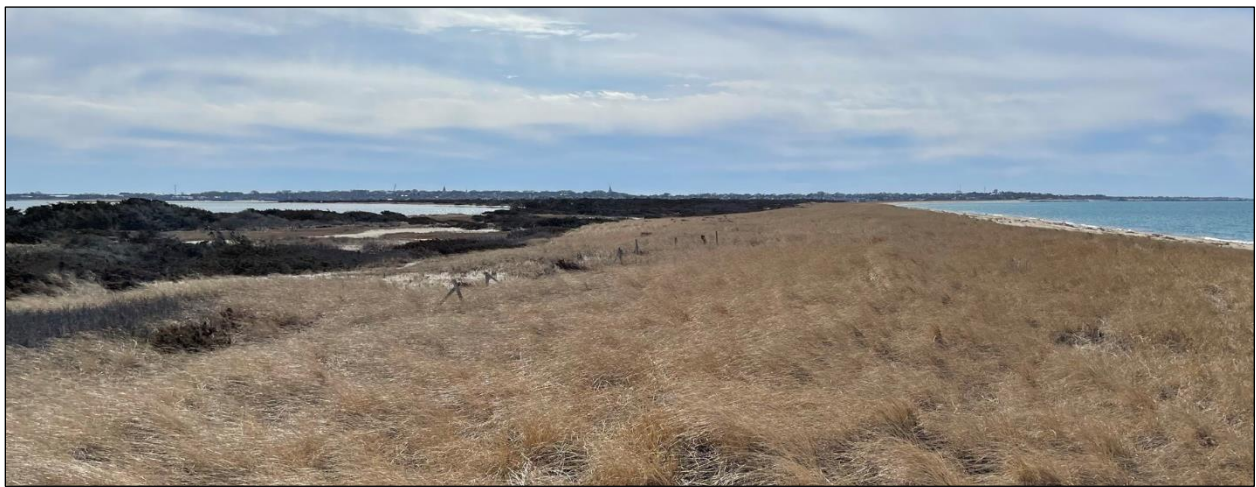
**Figure 58. Vegetated coastal dunes between 1st and 2nd Point (looking southwest).**

The cusped spits along the southerly shore of Coateue are a unique landform system that is thought to have formed from the perfect combination of dominant winds, waves, and longshore currents post-glaciation. These six cusped spits that extend as much as a half mile into the Harbor, have beautifully preserved recurved dune ridges, providing protection to inner marsh lagoons, and are the home to an abundance of terrestrial, avian, and marine wildlife. Piping plovers and American oystercatchers are known to nest in this area. Eastern prickly pear (*Opuntia humifusa*) can also be found throughout the barrier beach in this location. The area between 1st and 2nd Point is between two of these cusped features, with a landform consisting of barrier beach, coastal dunes, tidal flats, and salt marsh. The vegetation in the coastal dunes includes beach grass, cedars, and other low lying salt tolerant shrubs (Figure 58).

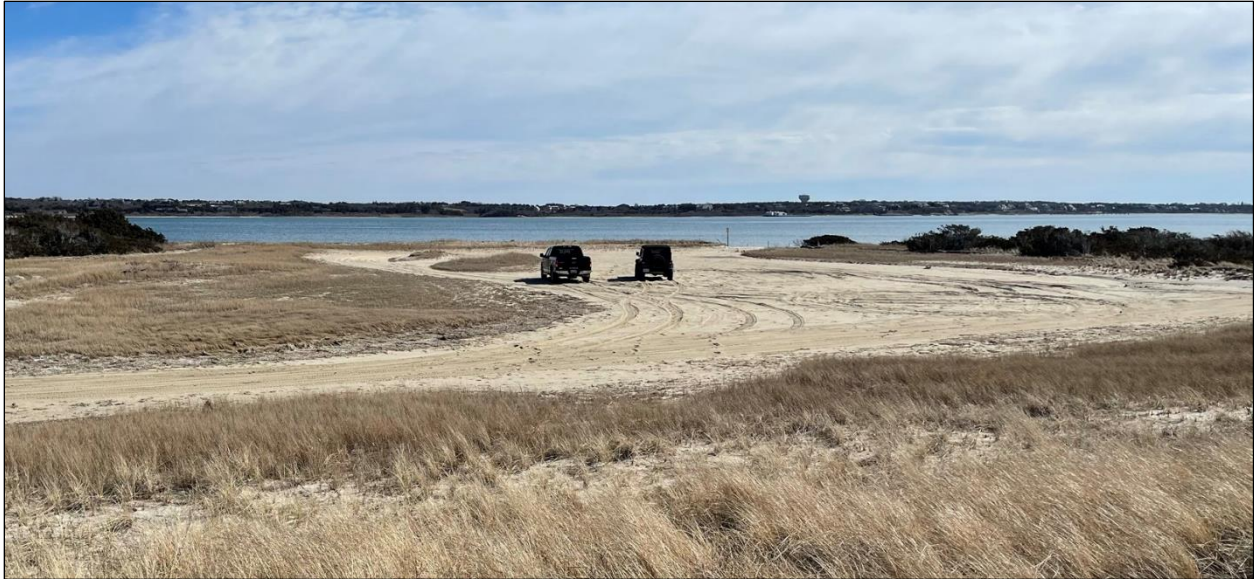
**Figure 59. Low-lying dirt parking area between 1st and 2nd Point.**

A sandy over sand vehicle trail that originates in Wauwinet extends all the way to 1<sup>st</sup> Point and provides public access to this remote and beautiful spot in the wildlife refuge. A small sandy parking area is situated between 1st and 2nd Point (Figure 59) and provides a place for the public to park while exploring Coateue.

The classification of the parking area as tidal flat is because it has a maximum elevation of 2.4 (NAVD88) based on the 2016 USGS LiDAR (Figure 61) and is frequently flooded. This limits access, which will likely get worse soon. The rest of the barrier beach is also relatively low-lying. The dunes have a maximum elevation of 9.4 feet NAVD88 (Figure 61) and are prone to erosion and overtopping.

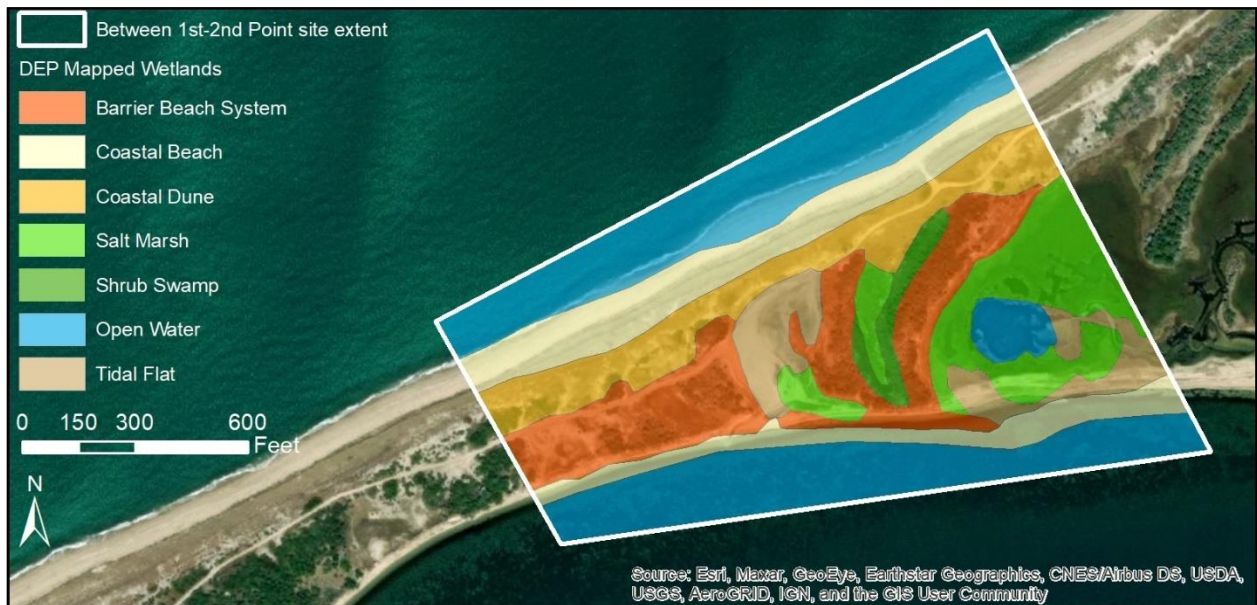
**Figure 60. Existing wetland resource areas, as mapped by MassDEP, between 1st and 2nd Point.**

The wetland resource area mapping produced by MassDEP shows the range of wetland habitats present between 1st and 2nd Point (Figure 60). Coastal beach and coastal dune are found along the northern (Nantucket Sound) side of the barrier beach. Forest- and shrub-dominated areas of the barrier beach are classified as “barrier beach system”. There is also significant salt marsh area in a lagoon connected to Nantucket Harbor through various circuitous inlets. Note that the dirt parking area mentioned above is classified by DEP as “tidal flat”.

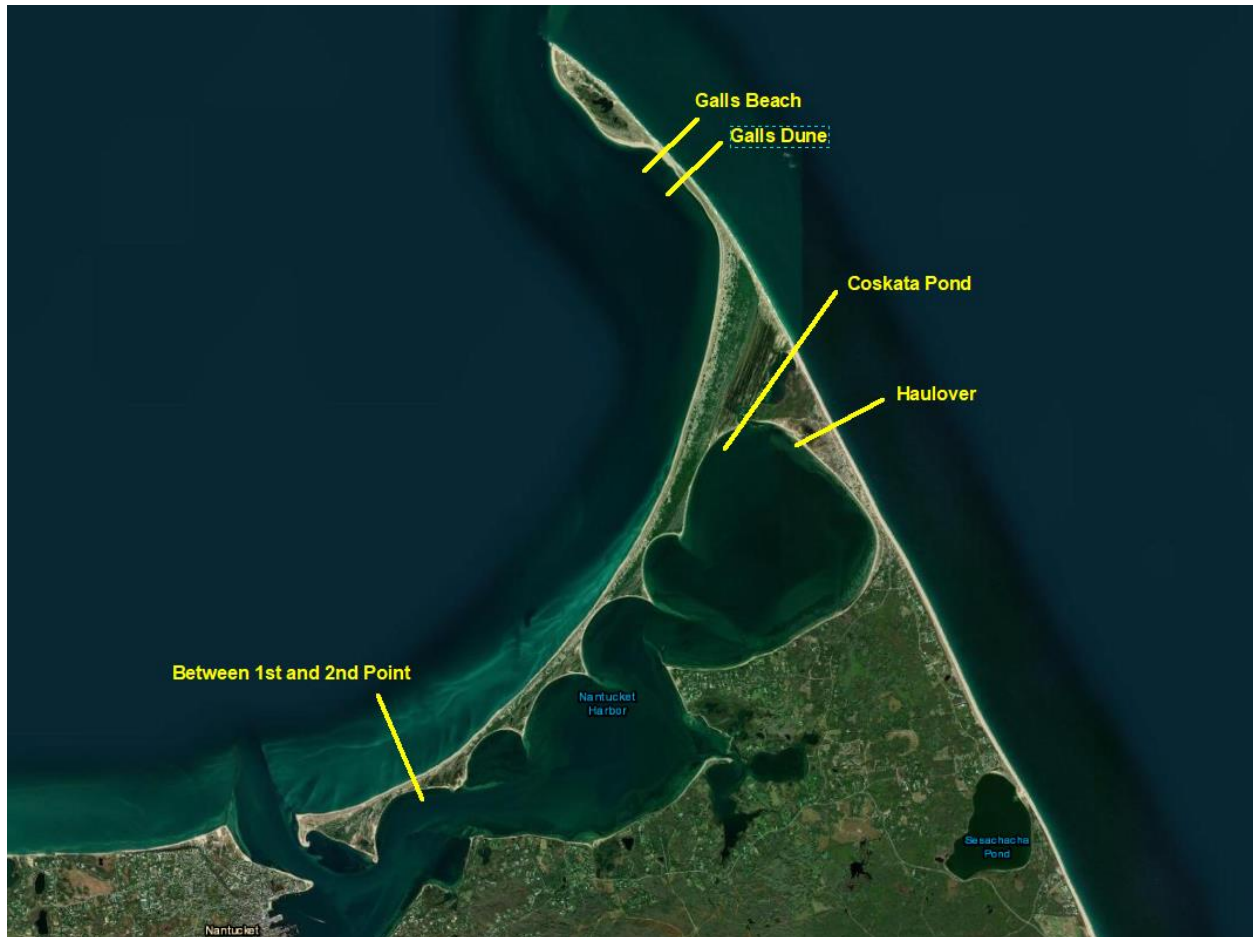
**Figure 69. Transect locations.**

To determine the resiliency of the dunes or coastal beach at each of the four areas we chose five transects (Figure 69) throughout the four focus areas and used the most recent available LiDAR survey data to establish a snapshot of the existing topography. Laboratory analysis of sediment samples we collected during our site visit provided the effective grain size information to input an expected bed friction value to model the erosion. Haulover Pond and Coskata Pond were chosen to investigate what would happen at the narrow points of the coastal beach with the ponds behind. The Galls beach and dune transects were chosen to represent the large changes in height between the open coastal beach and adjacent coastal dunes along that portion of narrow barrier beach. The last transect was chosen on the western side of the Coatue spit. These profiles were run in XBeach for a 1- and 2-year storm to see how they will erode during these storm conditions.
