**Assessment and Analysis of Adaptation Alternatives  
For Coskata-Coatue Wildlife Refuge Properties**

**April 2022**

Woods Hole Group  
A CLS Company  
107 Waterhouse Road  
Bourne, MA 02532 USA  
(508) 540-8080

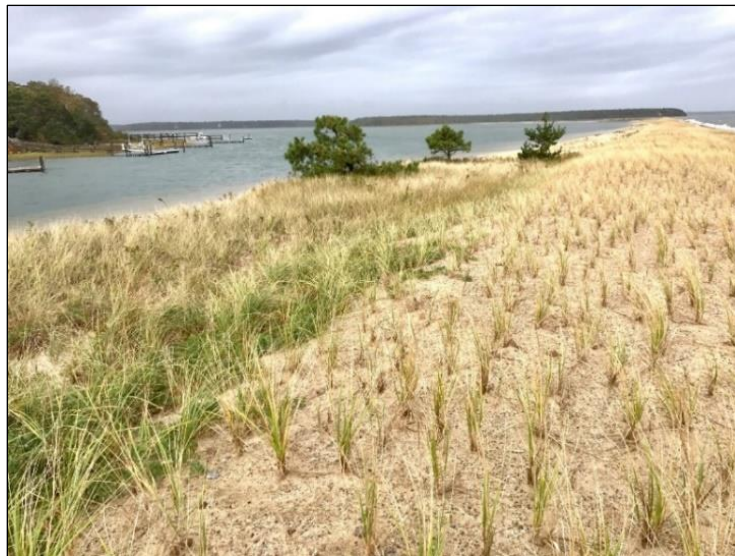
**Figure 80. Example of a hearty beach grass project on Cape Cod.**

Common in New England, American Beach Grass is a vigorous, upright grass that grows in dense clumps, is capable of rapid lateral spread by runners and is considered the true pioneering plant of the sand dune environment. Beach grass stabilizes dunes by holding sand in place and changes the environment by retaining moisture and nutrients, allowing other plant species to then colonize an area because of these changes. Beach grass catches sand as the leaves slow the speed of wind, allowing wind-blown sand to be deposited and hence the accumulation of a sand dune. Once beach grass is established and a dune becomes more stable, other plants can gain a foothold, thereby creating greater diversity for wildlife habitat and reducing the potential for a loss of all vegetation to disease or pests. Ongoing management of a beach grass project involves occasionally planting additional culms to fill bare areas, and removal of invasive species, such as knotweed, with less desirable properties that can outcompete the beach grass. Beach grass is widely used in conjunction with dune restoration projects and would be a viable stabilization alternative at any of the Coskata-Coatue sites. Figure 80 is an excellent example of a successful beach grass installation that was done as part of a dune restoration project on Cape Cod.

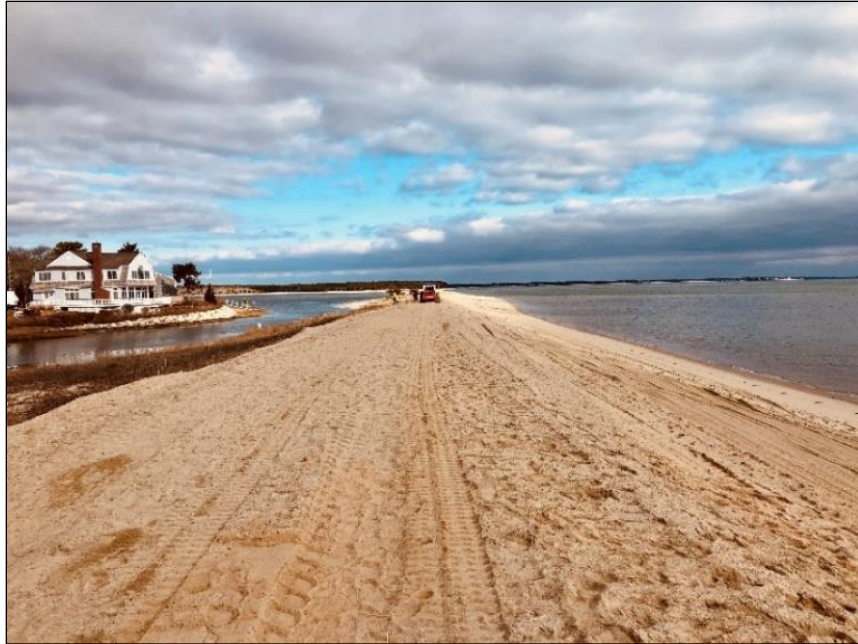
**Figure 81. Dune nourishment at Popponesset Spit in Mashpee.**

A barrier beach with an adequate dune system of adequate height and width can shift over time due to regular storms and changing currents. Nourishing the dune with the placement of sand and installation of vegetation could help to balance the equilibrium and increase the long-term resiliency of the barrier beach. Figure 81 is an example of a similar and successful dune nourishment project along Popponesset Spit, a barrier beach in Mashpee, MA.

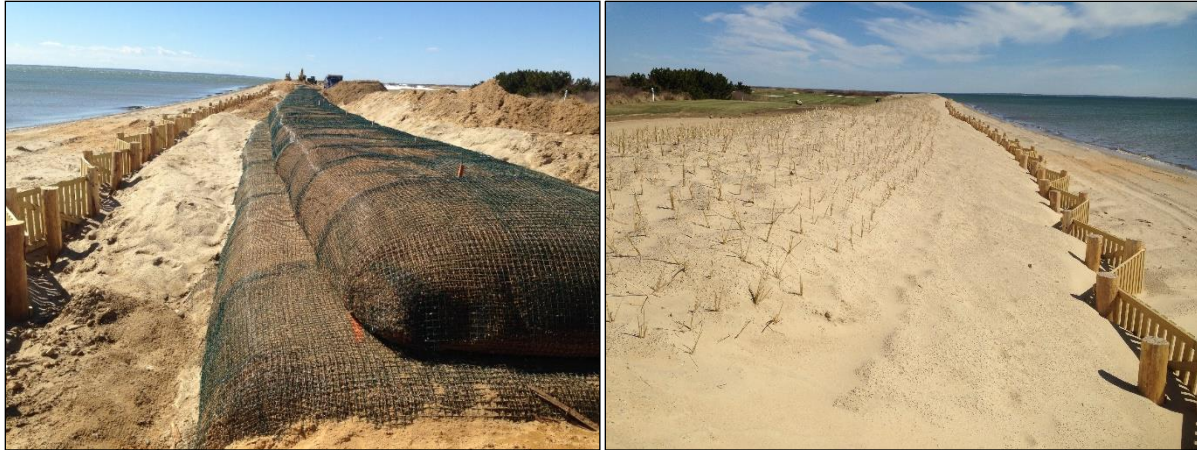
**Figure 82. Example of a coir project on Cape Cod, located in NHESP habitat.**

Dune stabilization projects using a bioengineered solution provide enhanced toe protection to the coastal dune and inland assets while restoring and enhancing the recreational value of the coastal beach, which is highly desirable. This alternative involves the installation of fiber rolls or sand filled coir envelopes at the toe of the dune to prevent undercutting and installing compatible nourishment sand on top to protect the fragile bioengineered material that will quickly degrade with prolonged exposure to UV light. Figure 82 is an example of a bioengineered project on Cape Cod. The addition of coir envelopes for toe protection can bolster the beach and dune nourishment alternatives discussed above and are considered a “soft” solution, often permitted under the State Wetlands Protection Regulations, 310 CMR 10.00. This solution had been previously permitted and installed at many other locations on Cape Cod and Nantucket and is considered a viable alternative for coastal stabilization on properties where hard coastal engineering structures are undesirable or prohibited by the State or Town. Dune stabilization can be paired with dune restoration to increase protection of the dune and allow greater time for the establishment of dune vegetation.

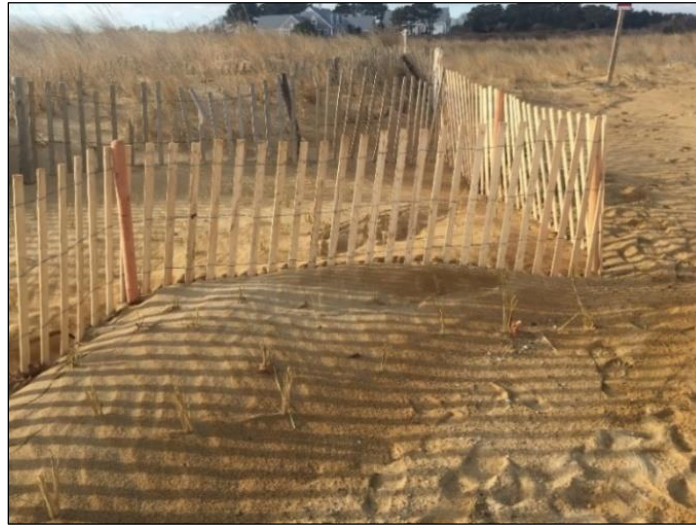
**Figure 84. Example of wind-blown accumulation at the base of drift fence in Edgartown.**

Installation of sand fencing is relatively non-invasive, and the fencing is both removable and can direct foot traffic away from delicate dune resources. For these reasons, design and permitting are less involved than more aggressive measures. There can be drawbacks to the use of fencing on beaches. Fencing can become a perch for predators. Additionally, nesting shorebirds (such as plovers and terns) need to migrate from oceanfront beaches to protected bays and ponds, but young birds can be impeded by fencing. This can be mitigated by spacing sand fences with gaps. Figure 84 provides a photograph of sand fence installed locally.

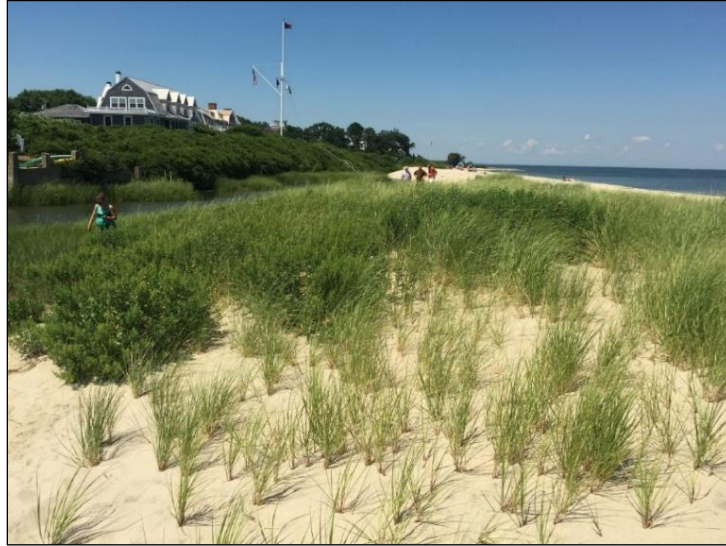
**Figure 85. Example of a successful thin layer sediment placement project in an overwash area at Fuller Street Beach, Edgartown.**

Thin-layer deposition can similarly be used in low-lying overwash areas on barrier beaches to improve resiliency and maintain a frequently overtopped nesting habitat. The application includes placing thin layers of compatible sediment in the low-lying area to raise the elevation and reduce the frequency of storm overtopping. Typically, the sediment placement would range from 6-12” and would be placed over a broad area with gentle side slopes. The intent of a thin layer sediment placement project is to raise the elevation of the overwash just enough to improve resiliency, while maintaining the function of the habitat. Figure 85 is an example of a thin layer sediment

placement project in an overwash area at Fuller Street Beach in Edgartown that naturally colonized with native plants and remains a suitable nesting habitat. This alternative would require compatible sediment to the barrier beach system and provide protection for the habitat but would not resolve the issues associated with the OSV access.

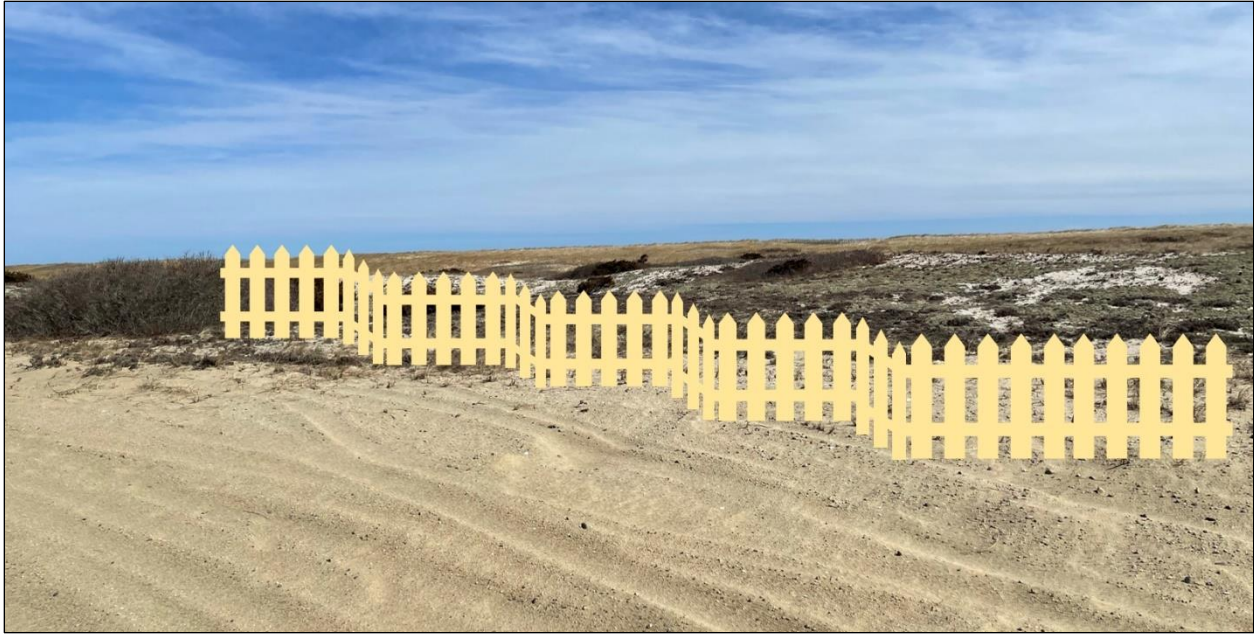
**Figure 91. Conceptual sand fencing placement along roadway at The Haulover.**

A short term, interim approach may be pursued at the Haulover to attempt to improve conditions while a longer-term solution is developed. Sand fencing can be installed relatively easily to provide a means to trap sand. Fencing could be installed in a zig-zag pattern along the existing OSV roadway to capture sand in the secondary dune area, with the goal of building dune and roadway elevation (Figure 91). Sand fencing can provide the secondary benefit of being a demarcation and barrier for pedestrians and vehicles from impacting sensitive resources. Planting and management of beach grass can accompany sand fencing to further enhance sand capture, and improve habitat conditions, especially in areas which have been previously overwashed and have relatively less vegetation than less-impacted adjacent dunes.

Sand fencing could be installed in the secondary dune area, as opposed to at the toe of the dune, because the high wave energy of the site would soon be likely to washout the fencing in a storm. While placement along the roadway will have a longer lifespan, it is not anticipated that fencing will be sufficient to prevent erosion or overwashing. Should there be a concern that fencing may impede young shorebirds from moving from beach to inland bay, the fencing could be installed with evenly spaced gaps. Additionally, monitoring should follow installation to see if fences become a perch for predators.

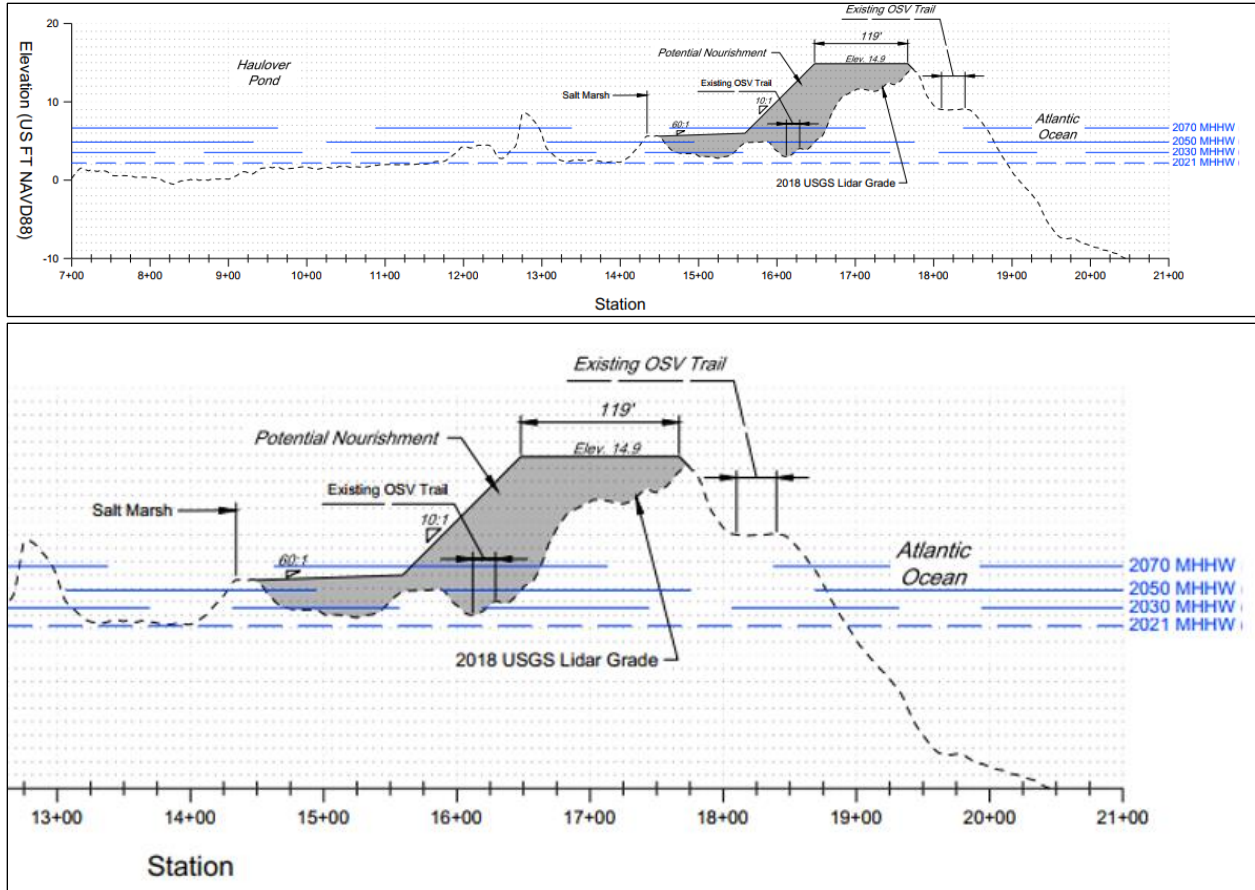
Figure 92. Conceptual design for a dune nourishment at The Haulover.

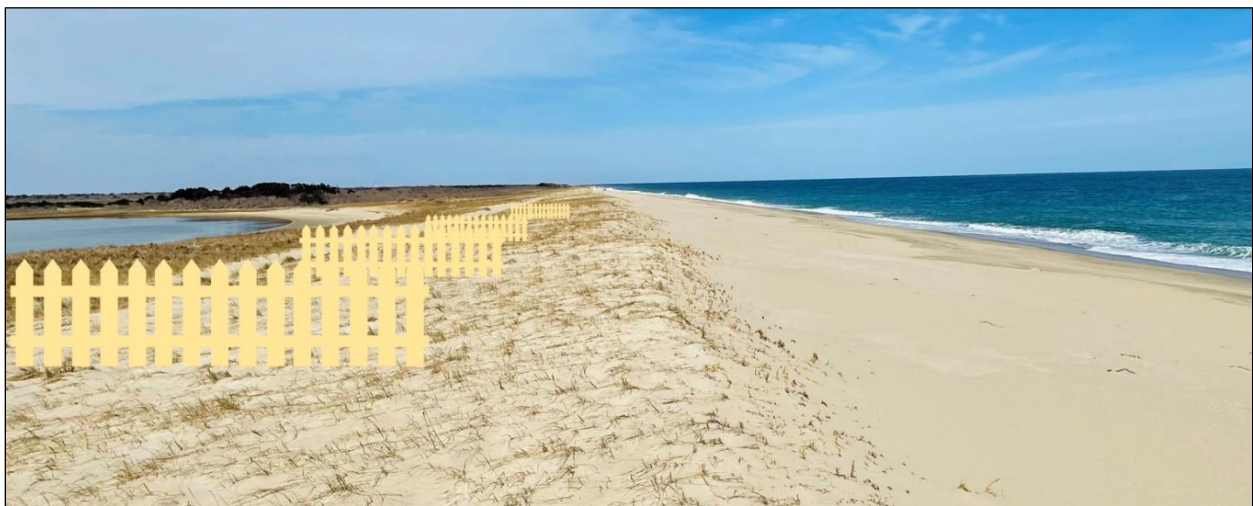
A short term, interim approach may be pursued at Coskata Pond to attempt to improve conditions while a longer-term solution is developed. Sand fencing can be installed relatively easily to provide a means to trap sand. Fencing could be installed in a zig-zag pattern along the existing OSV roadway to capture sand in the secondary dune area, with the goal of building dune, and potentially roadway elevation (Figure 97).

**Figure 97. Conceptual sand fencing placement along roadway at Coskata Pond.**

Sand fencing can provide the secondary benefit of being a demarcation and barrier for pedestrians and vehicles from impacting sensitive resources. Due to the low elevation of certain reaches by Coskata Pond, sand could be imported to pre-nourish the dune and sand fencing area. Planting and management of beach grass can accompany sand fencing to further enhance sand capture, and improve habitat conditions, especially in areas which have been previously overwashed and

have relatively less vegetation than less-impacted adjacent dunes. Sand fencing could be used behind the foredune, as opposed to at the toe of the dune, because the high wave energy of the site would likely damage the fence on the seaward side in a storm. While placement along the roadway will have a longer lifespan, it is not anticipated that fencing will be sufficient to prevent erosion or overwashing. Should there be a concern that fencing may impede young shorebirds from moving from beach to inland bay, the fencing could be installed with evenly spaced gaps. Additionally, monitoring should follow installation to see if fences become a perch for predators.

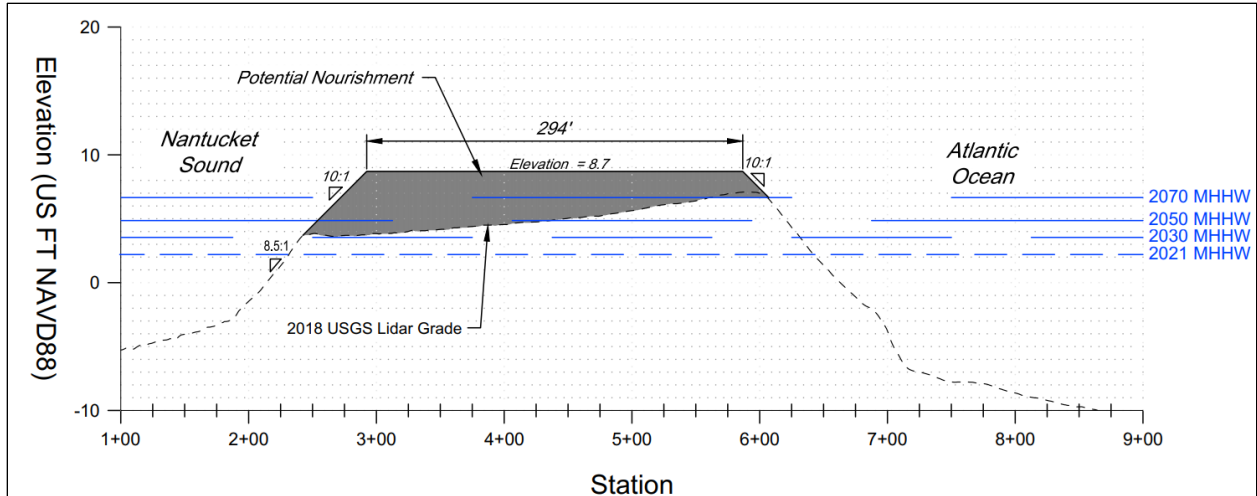
Figure 103. Conceptual design for the beach nourishment alternative at The Galls.

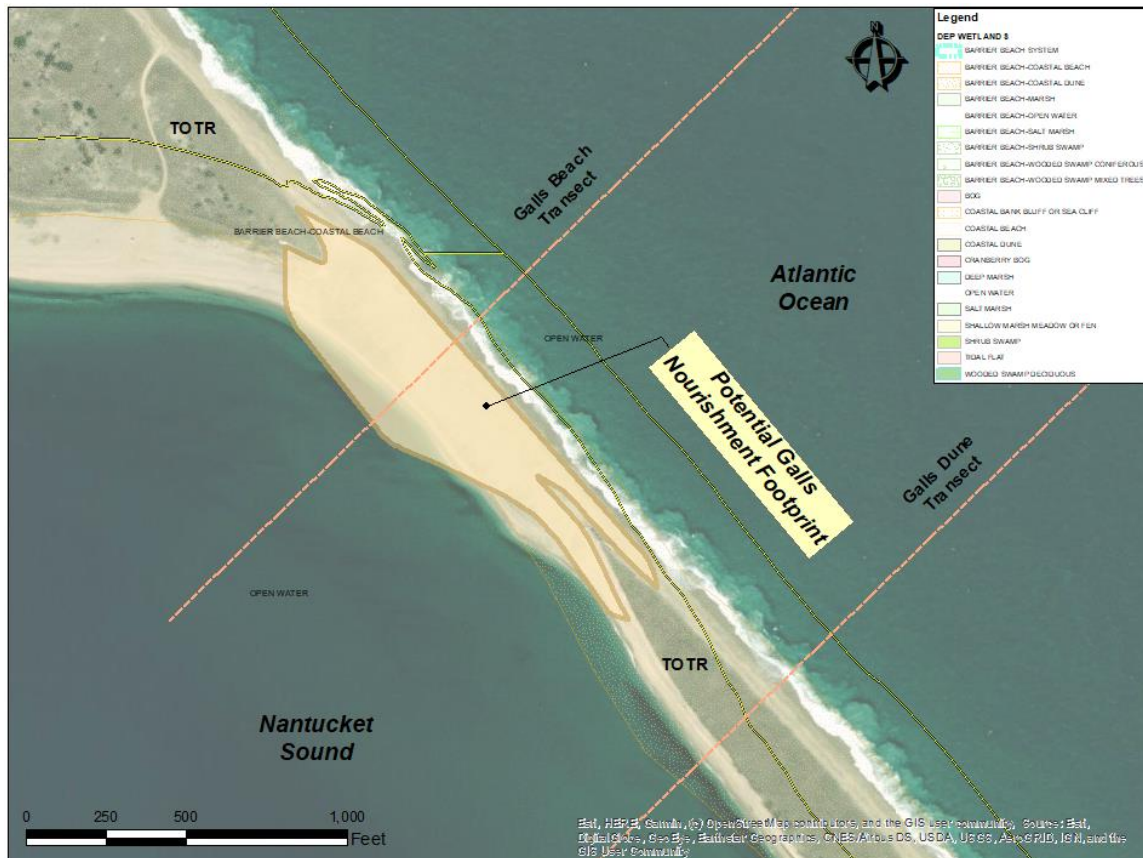
Figure 104 shows the footprint of a beach nourishment alternative that blends into the adjacent coastal dunes. The nourishment would extend along 1,600 linear feet of beach and would require approximately 65,000 cubic yards of beach compatible material. Details for sand sourcing and construction methods would be determined during the permitting process but could come from a local dredging project or an upland source.

Figure 104. Potential beach nourishment footprint at The Galls.

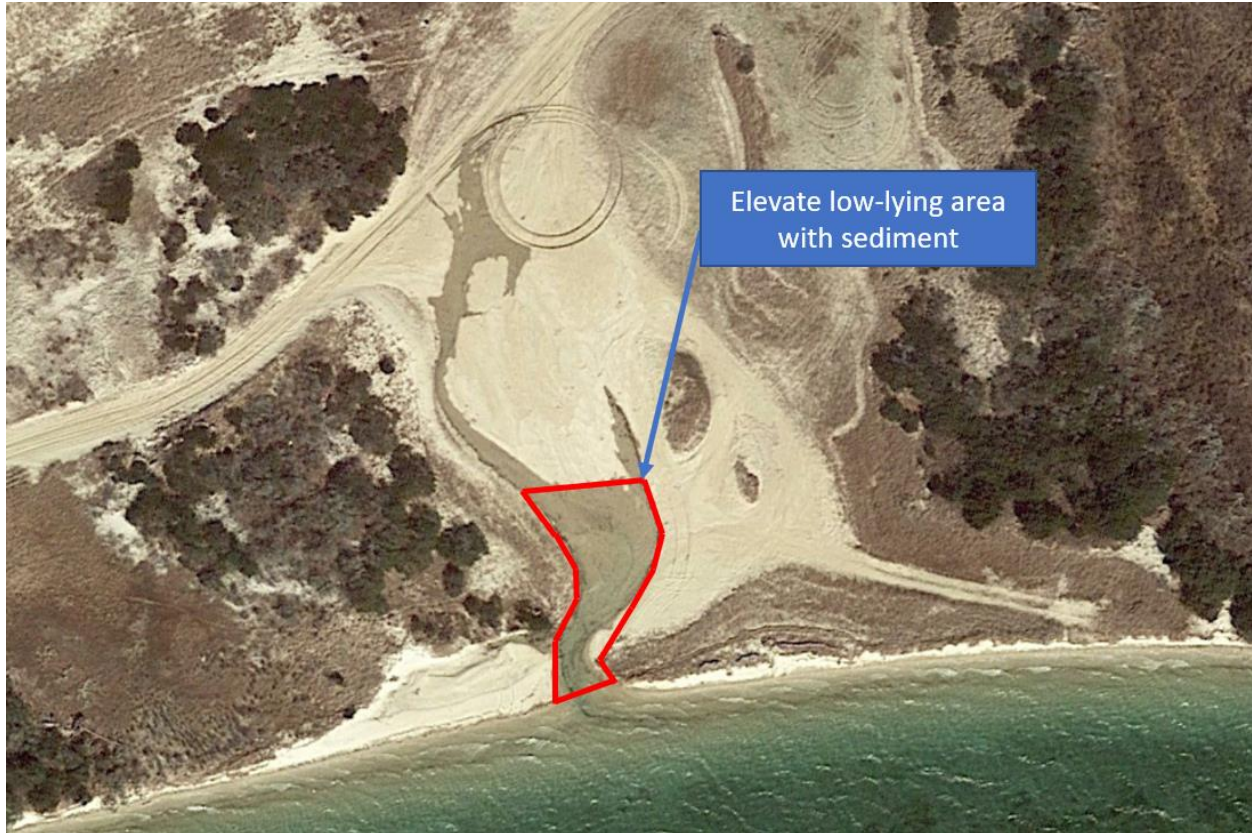
A short term, interim approach may be pursued at 1<sup>st</sup> and 2<sup>nd</sup> point to attempt to improve conditions while a longer-term solution is developed. The seaward beach and dune at this site are considered relatively stable. Therefore, the interim approach would address the most pressing issues in the area, understood to be flooding on the backside of the barrier spit, where a low sandy parking area can be wetted by extreme tides, storm surge, and wind waves. Improvements to this section would be the import of a relatively small volume of sandy material to patch the low-lying areas and minimize future flooding of the parking area. While an elevated linear dune along the bay-side would provide some protection from overtopping, it would also create a potential risk for retaining stormwater. A more appropriate approach is to elevate the entire low-lying area above the king tide line and ensuring that the topography continues to slope towards the bay to promote drainage (Figure 107). Vegetation management with dune plantings and sand fencing could be implemented in areas where parking is prohibited to improve sand capture and stabilization and minimize the risk for trampling by visitors and drivers.

**Figure 107. Conceptual footprint for elevation with import at 1<sup>st</sup> and 2<sup>nd</sup> Point – February 2018 Aerial**

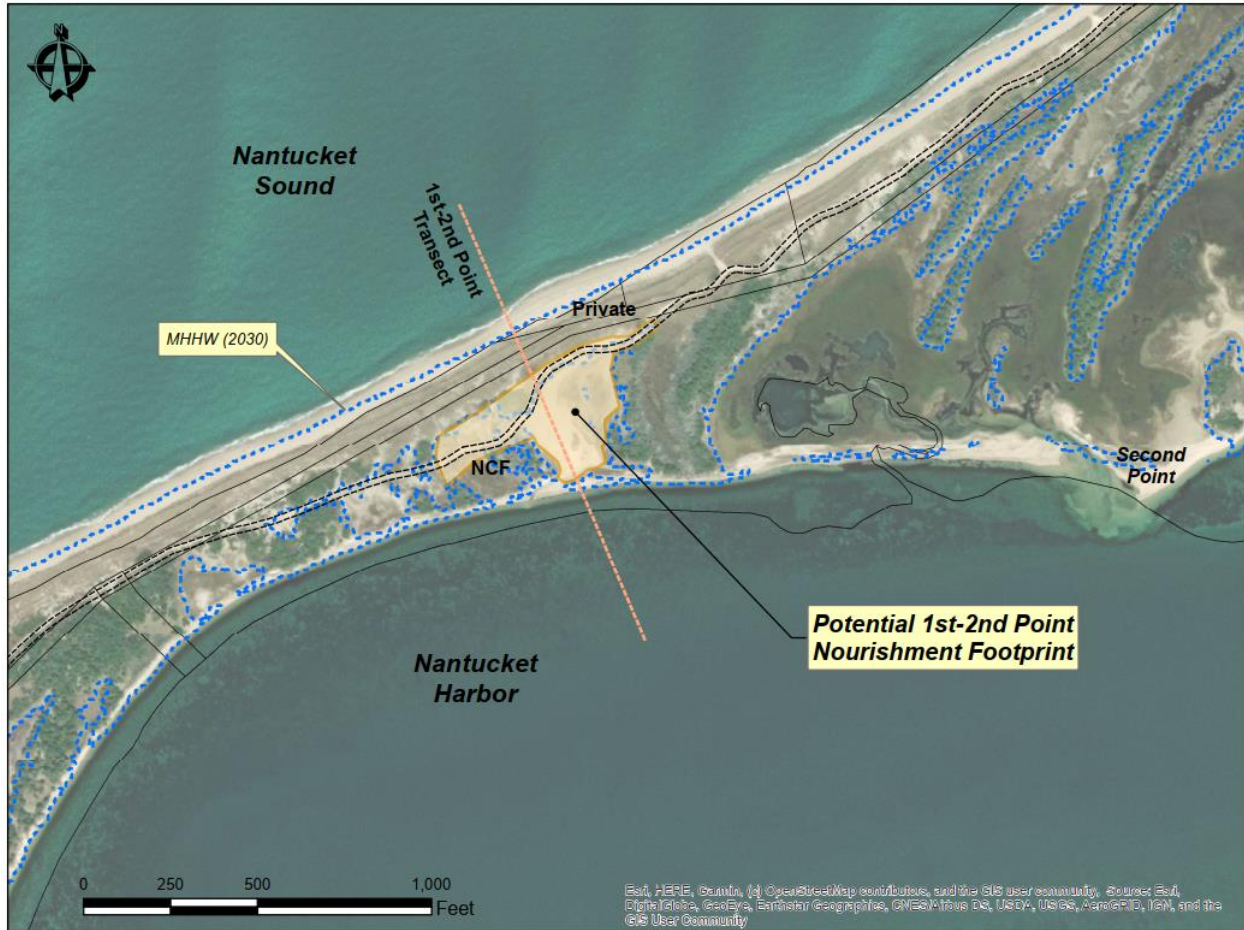
**Figure 109. Potential dune nourishment footprint between 1st and 2nd Point.**
